Miller's House, Wye Mills (Wilton)

Architectural Survey File

National Register of Historic Places Registration Form

historic name Miller's House
other names T-70

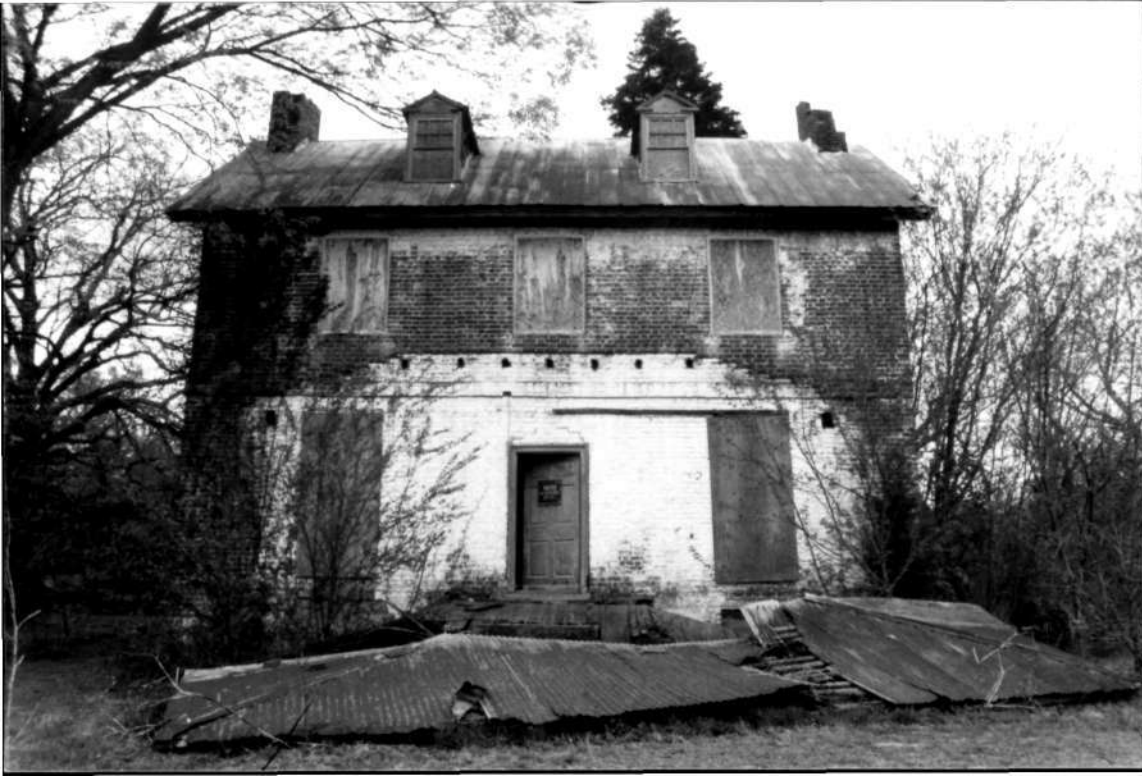
Miller's House
T-70

View from N
S. Del Sur to
June 1955

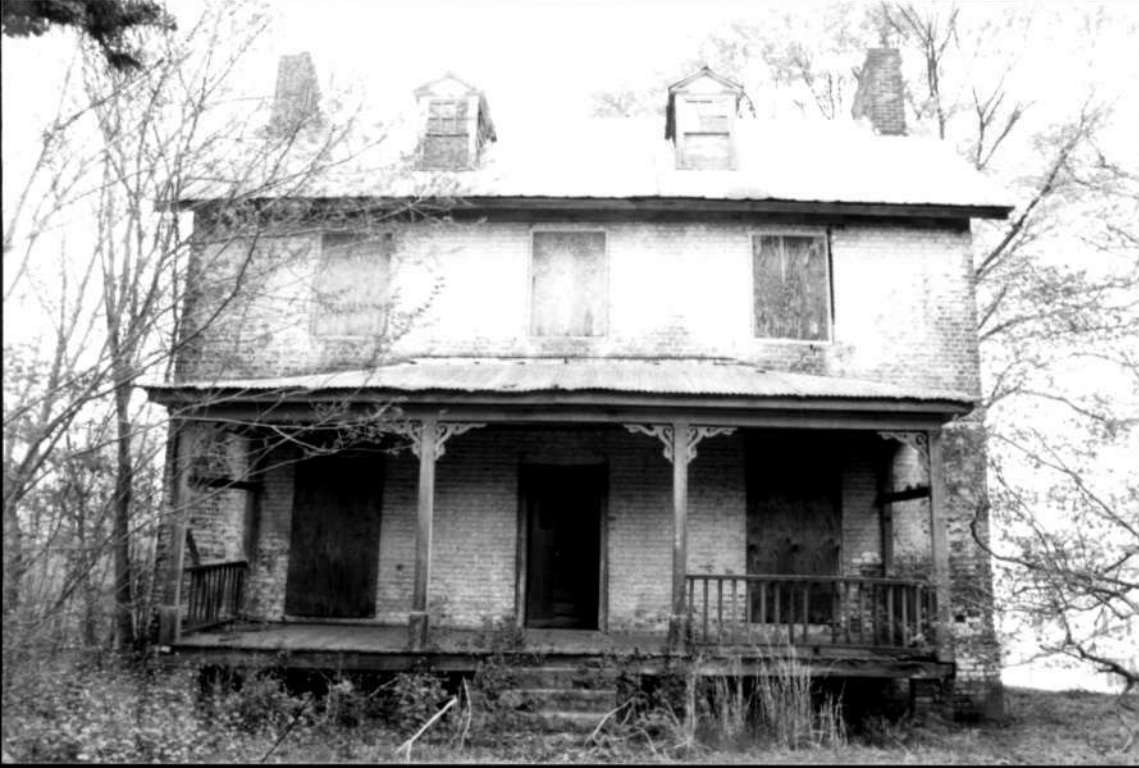
Miller's House
T-70

view from S
S. Del Jorito
June 1959

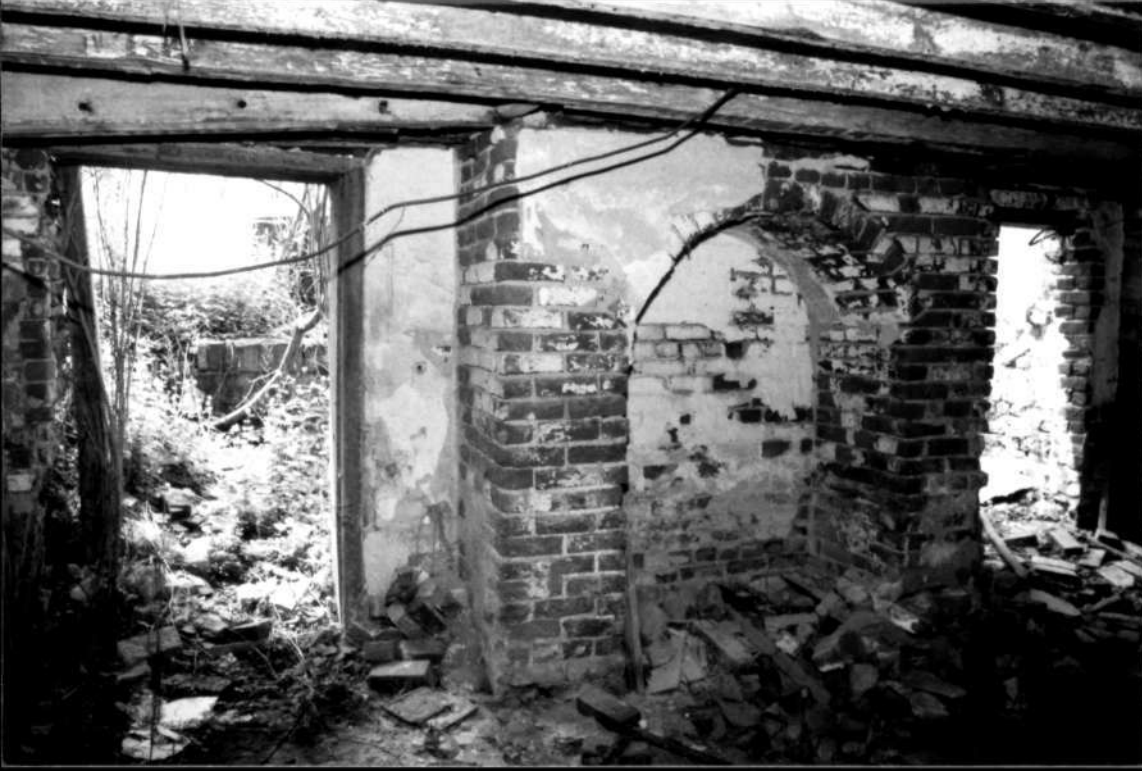
Miller's House

View from E - basement - West
S. Del Surdo well

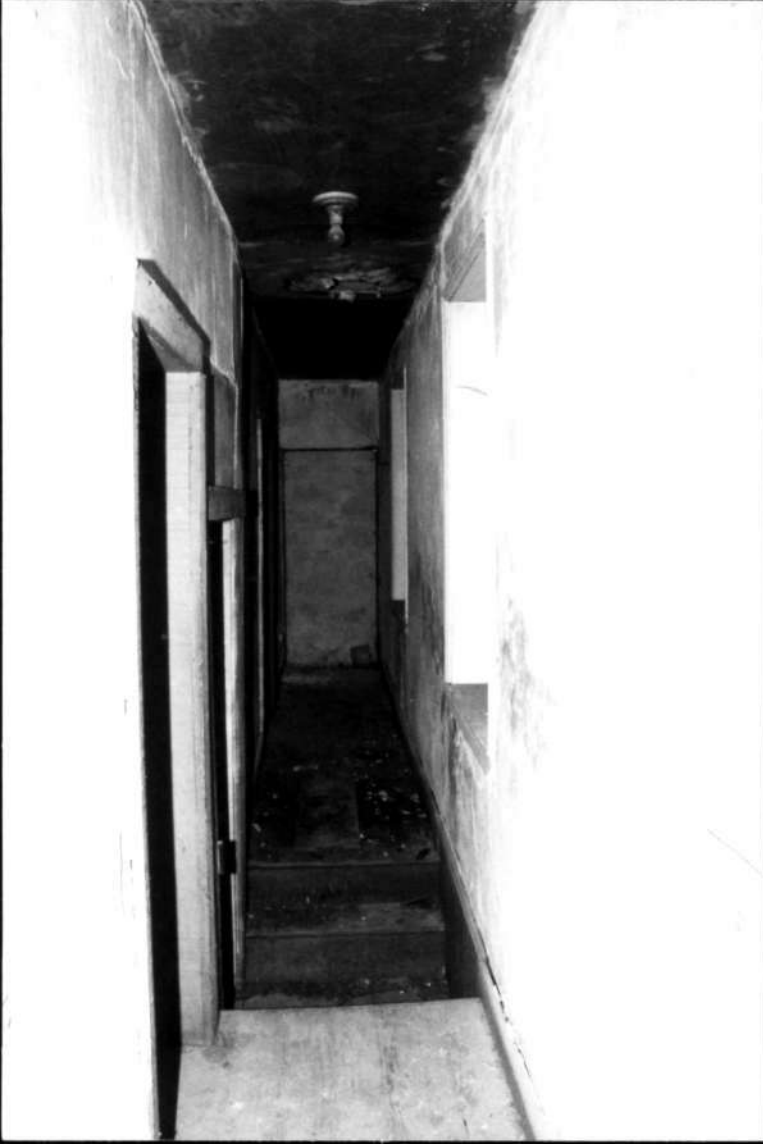
M. Heer's House
T-20

View from East
3rd floor hallway

Access to the upper level or attic of the house is by the half-winder stairs at the east end of the second-floor hallway. These steps lead to a third-floor hallway that runs along the north wall and provides access to the three rooms in the upper level. In some respects this hallway might be considered a separate room in that it extends from the north wall to almost the middle of the floor area. In addition, it ends before the west end wall of the

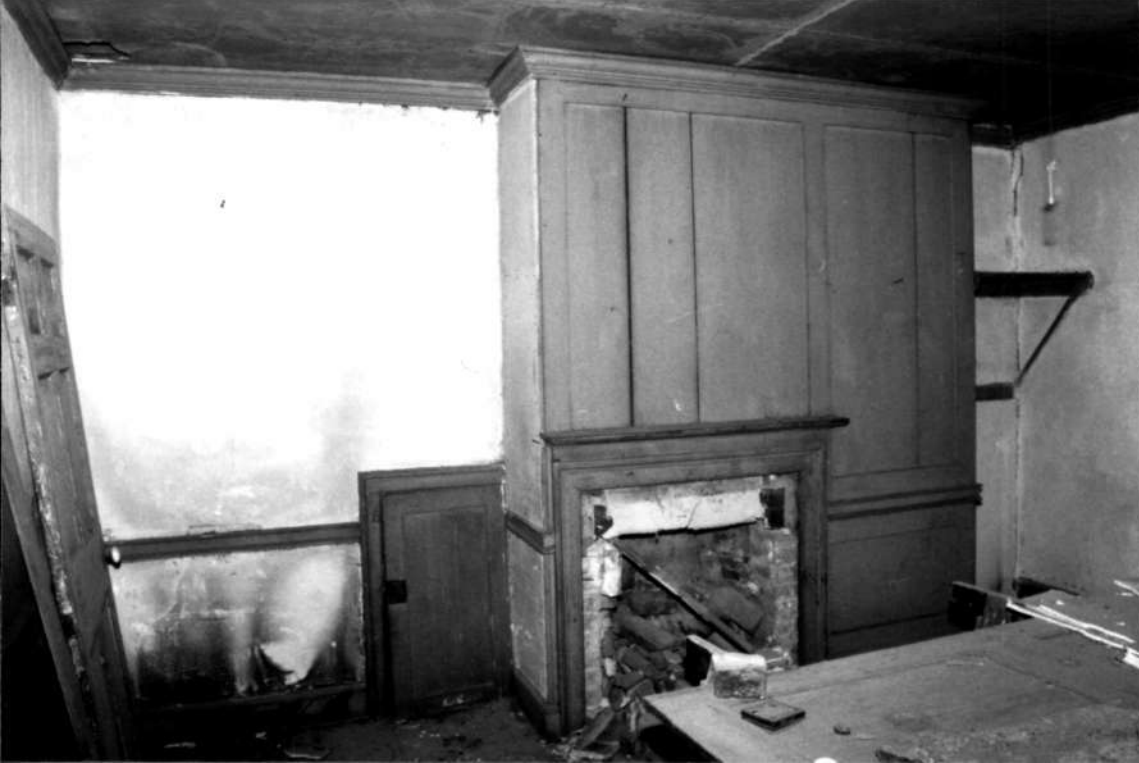
Miller's House
T-20

view from E
2nd floor - west room
S. Del Jorda
June 1959

The westerly room is the largest room on the second floor. The walls are finished in plaster with a baseboard, chair rail, and cornice as decorative features. The room is dominated by the chimney piece. The fireplace mantel is a simple piece composed of planed boards pegged together with a narrow shelf at the top. The mantel is affixed to a paneled chimney piece. The paneling consists of wide vertical boards secured by edged boards and surmounted by a cornice. The mantel and fireplace are offset to the left or south side of the chimney.

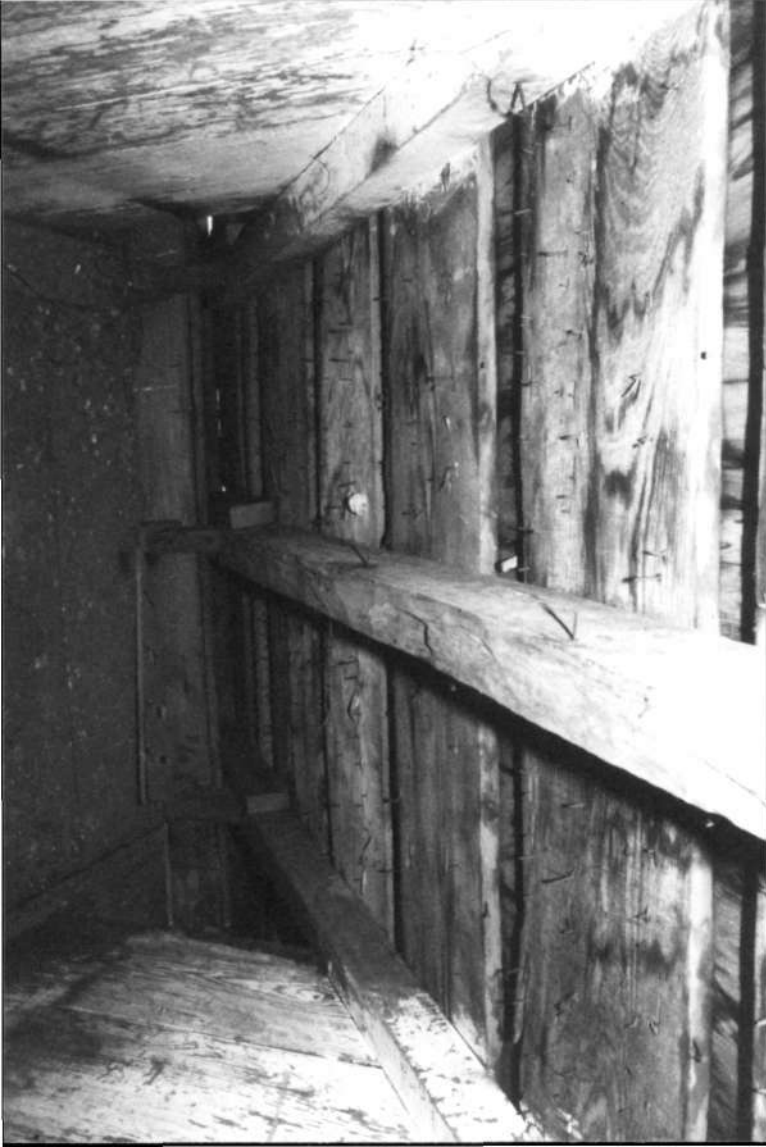
Miller's House
T-70

ATTIC Level = roof frame

Based on the small portion of the roof framing that is exposed in the middle room, the current roof is a common rafter roof with wide plank nailers that run perpendicular to the rafter blades. The wood singles that are underneath the tin roof are secured to the planks. The nails that are exposed from the roofing materials are a mixture of wire nails and machine-made cut nails.
